NUMBER: 08-057-05

DATE: October 27, 2005

Instrument Cluster EVIC - 12,000 Km / 7,500 Mi Service Interval Added

2005 (WH) Grand Cherokee (International Markets)

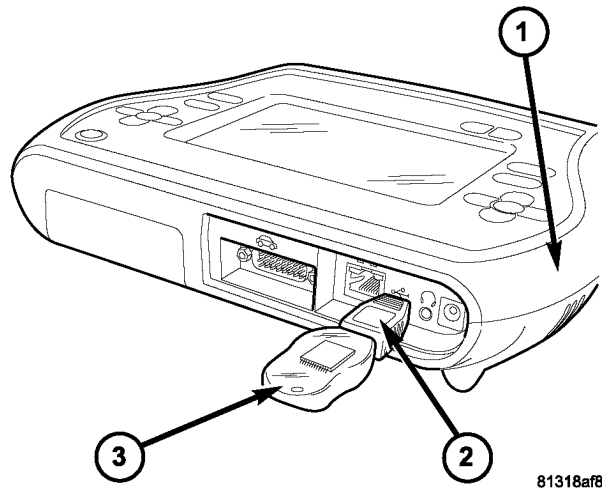
Fig. 1 USB KEY, GENDER CHANGER, AND StarSCAN® TOOL

- 1 - StarSCAN® TOOL
 2 - GENDER CHANGER
 3 - USB KEY

7. With the StarSCAN® powered OFF, connect the USB Key and Gender Changer to the StarSCAN® USB port (Fig. 1).
