NUMBER: 03-004-07

GROUP: Differential &
Driveline

Ringing Sound Coming From Propeller Shaft When Transmission Is Shifted From Drive To Reverse Or Reverse To Drive

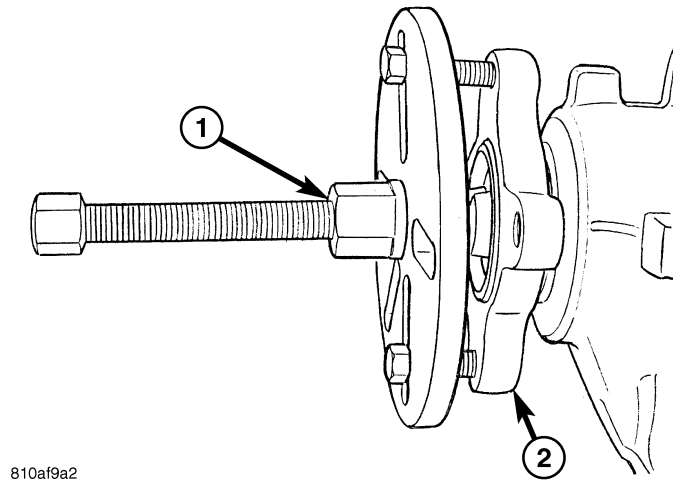
Fig. 1 FLANGE PULLER

- 1 - FLANGE PULLER #8992
- 2 - PINION FLANGE

2. Using Special tools C-3281 and 8992, remove the transmission output shaft nut and remove the flange([Fig. 1](#)).
