NUMBER: 08-021-05

Poor Radio Reception - Signal May Ground At Antenna Base Due To Metal Debris

2005 (WK/WH) Grand Cherokee

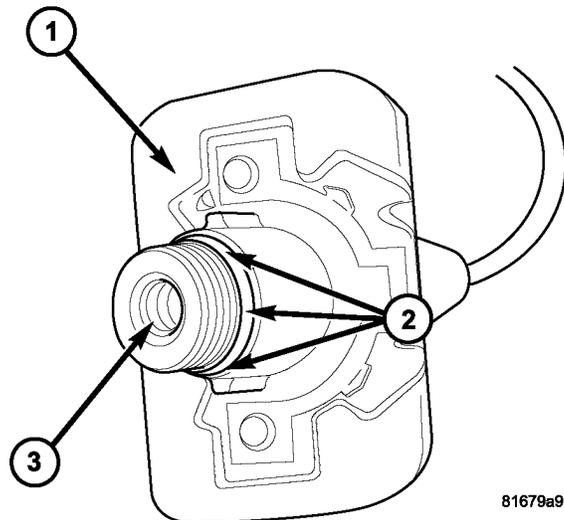
Fig. 1 ANTENNA BASE & INSULATOR

A black insulator is molded into the antenna body. The insulator is used to isolate the brass center conductor (antenna mast signal) from the body grounded cast metal housing of the antenna base. Brass thread filings may fall from the center conductor and may create a ground path across the **top surface** of the antenna base insulator. The metal filings may be a "trail" of fine pieces of brass and/or thin strips of brass thread shavings. If present, the filings may move during vehicle use and cause intermittent signal reduction or loss.

- 1 - ANTENNA BASE - GROUNDED TO VEHICLE BODY
 2 - BLACK INSULATOR - METAL DEBRIS MAY BE ON TOP SURFACE CAUSING WEAK OR NO RADIO SIGNAL
 3 - CENTER CONDUCTOR - BRASS METAL

6. Thoroughly clean the antenna cap nut and the entire antenna base of any brass filings. Verify that no brass filings are present on the top surface of the molded-in black insulation in the antenna base (Fig. 1).
