NUMBER: 08-022-07

GROUP: Electrical

DATE: September 15, 2007

Intermittent Illumination Of The Courtesy Lamps And Liftgate Ajar Indicator With Chime Tone

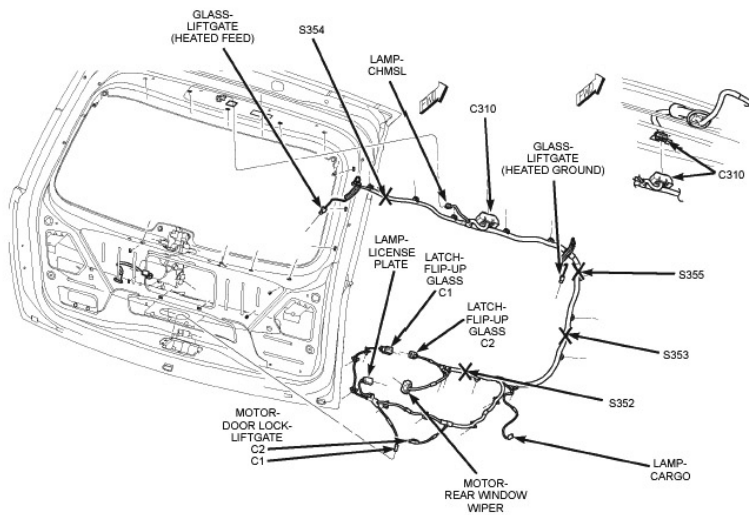
Fig 74 LIFTGATE

Customers may observe illumination of the courtesy lamps, a chime tone and the liftgate ajar indicator message illumination when the liftgate is not open. This is caused by intermittent contact of the liftgate open sensing wire closing the circuit to ground. Swapping the wires will make the intermittent contact with the body on the ground side wire, eliminating the false illumination and indicator messages.

C1
2-way connector, with black wire
and violet/orange wire

3. Measure the voltage at cavity 1 of the 2-way liftgate ajar switch connector.
4. Is the voltage above 10 volts?
 - a. Yes >>> Further diagnosis is required, this service bulletin does not apply.
 - b. No >>> Proceed to [Step #5](#)
5. Turn ignition key off.
6. Swap wires in the 2-way liftgate ajar switch connector. Cavity 1 should contain the "G78 - liftgate ajar switch sense circuit" and cavity 2 should contain the "Ground" circuit.
