NUMBER: 08-060-05

No Engine Crank - Loss Of Communications With Front Control Module

2006	(HB)	Durango
2006	(ND)	Dakota
2006	(WK)	Grand Cherokee
2006	(XK)	Commander

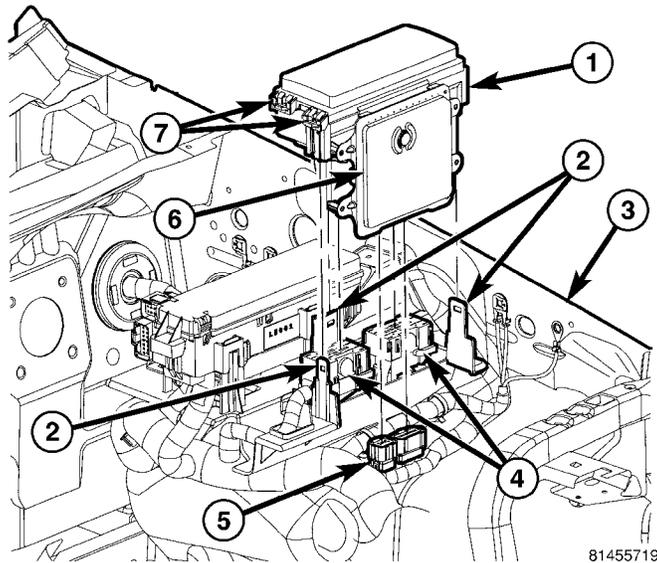
Fig. 1 IPM REMOVAL

-
10. Leaving the FCM attached to the Integrated Power Module (IPM), remove the IPM from its plastic support bracket (Fig. 1).
 11. Disconnect the two 40-way electrical connectors from their electrical cavities on the back of the IPM housing. Do NOT disconnect the two electrical connectors to the FCM.
