NUMBER: 21-016-05

GROUP: Transmission

DATE: September 01, 2005

RFE Transmission - Delayed Engagement After An Extended Off Period

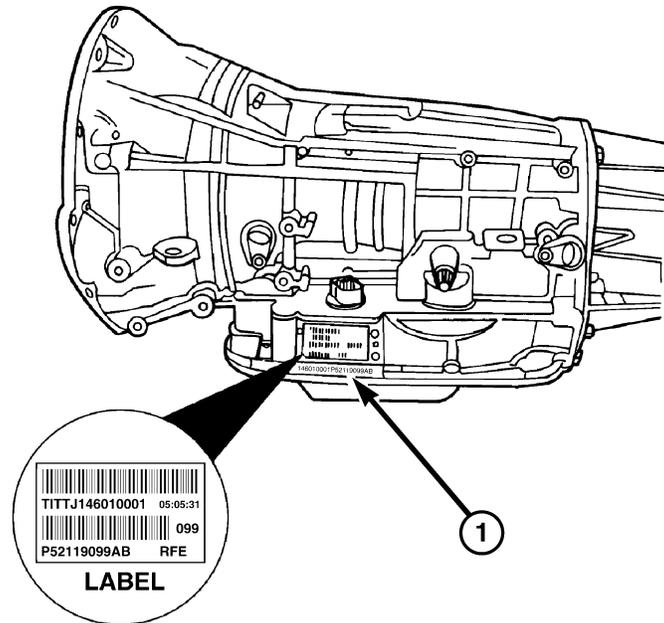
Fig. 1 TRANS IDENTIFICATION NUMBER

3. Inspect for the transmission build date (Julian date) (Fig. 1). The transmission build date can be determined by inspection of the 20 digit transmission identification number (**DDDYxxxxxPpartnumber**). The transmission identification number is stamped on the left side (driver side) of the transmission oil pan flange. The first four (4) digits of the transmission identification number are the transmission build date, in Julian date format. An example of a transmission identification number would be : **101510492P52119684AA**. The first three digits (**101**) of the identification number equal the day of the year, in this case 101 equals April 11. The fourth digit (**5**) of the identification number equals the calendar year, in this case 5 equals 2005. So 1015 equals April 11, 2005.

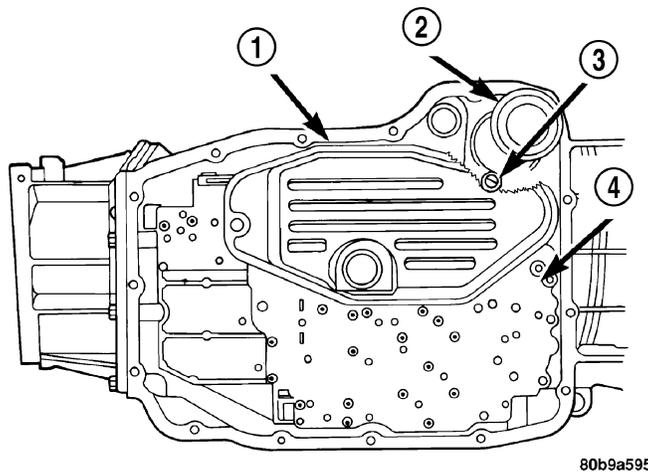
Fig. 2 Transmission Filters - 4X4 Shown

The condition may be caused by a suspect cooler return filter with a part number of 04799662**AB**. The suspect cooler return filter may allow transmission fluid to drain back out of the torque converter when the engine is not running.

NOTE: All cooler return filters with the “AB” suffix (04799662AB) are suspect. The above condition may be corrected by replacing a suspect “AB” filter with a new cooler return filter whose part number is 04799662 (with no suffix or with a suffix that is other than the “AB” level).

NOTE: A replacement 04799662 cooler return filter may come packaged with a separate threaded adapter stud. The threaded adapter stud is used to attach the cooler return filter to the transmission. Inspect the stud and note end without threads. Install the stud end without the threads into the cooler return filter and tighten the stud-to-filter connection to 18.6 Nm (165 in. lbs.). Once the threaded adapter stud has been installed to the cooler return filter, install the assembled cooler return filter to the transmission and tighten the filter to 14.1 Nm (125 in. lbs.)
