**NUMBER:** 23-007-07

Water leak At "C" Pillar Accumulates Water In Drivers Foot Well

2007 (WK) Grand Cherokee

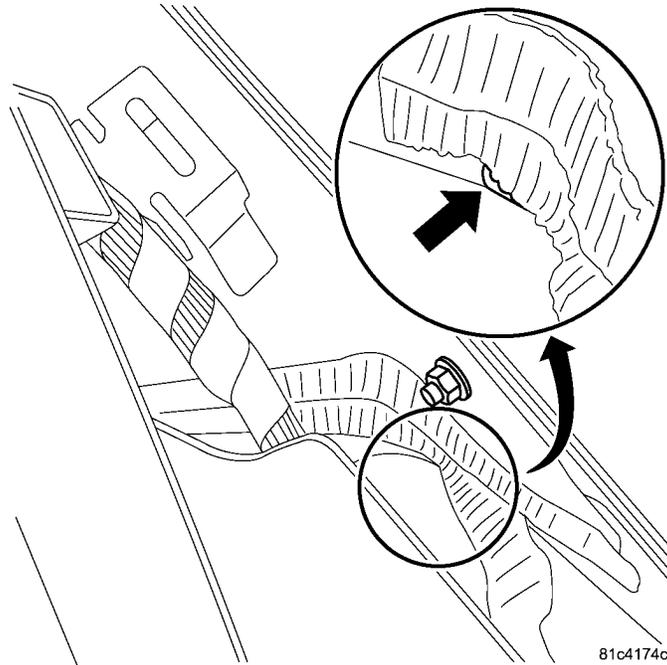
**Fig. 1 SEALER APPLICATION**

A sealer skip at the "C" Pillar floor seam could lead to a water leak which will travel along the rocker panel and accumulate in the driver side foot well.

1. Open driver side rear door and remove the scuff plate located in the lower center area of the door opening.
2. Pull the primary seal off from the bottom and half way up the C pillar to expose the opening between the trim panel and the inner sheet metal.
3. Carefully pull on the trim panel and loosen it from the lower attachment clip and bottom locator. Pull inboard to expose the lower floor seam area.
4. Locate the exposed flange with missed paint sealer at the rear wheel house inner to rear floor joint(Fig. 1). First make sure the area is clean and completely dry and then thoroughly cover the exposed area with Seam Sealer. Push the sealer into the flange area. Allow sealer to dry.

5. Install the trim panel.
6. Install the door seal.
7. Install the scuff plate.
