NUMBER: 23-024-05

Squeak-Like Sound When Outside Door Handle Is Used/Pulled

2005 (WK/WH) Grand Cherokee

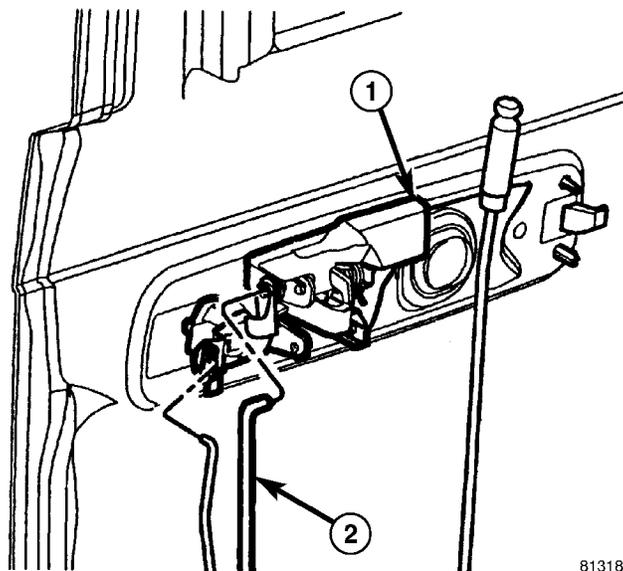
Fig. 1 HANDLE AND LOCK ROD

1 - Door Handle With Counterweight

2 - Latch Rod

1. Raise the window to the full up position and temporarily tape the glass in place.
2. Remove the door trim panel.
3. Remove the speaker and water shield. While the water shield is temporarily removed, the adhesive seal around the perimeter of the water shield must remain clean and not become contaminated.
4. Loosen the window regulator glass clamp bolts.
5. Lower the window regulator.
6. Loosen the top bolt and remove the lower bolt to the rear half of the window regulator. Move the rear half of the window regulator out of the way in order to gain access the door handle latch rod and clip
7. Disconnect the latch rod from the back of the outside door handle (Fig. 1).

- 1. Raise the window to the full up position.
- 2. Remove the door trim panel.
- 3. Partially remove the rear half of the water shield. While the water shield is temporarily removed, the adhesive seal around the perimeter of the water shield must remain clean and not become contaminated.
- 4. Remove the bolts used to secure the glass run channel to the door. Remove the glass channel from the door.
- 5. Disconnect the latch rod from the back of the outside door handle (Fig. 1).

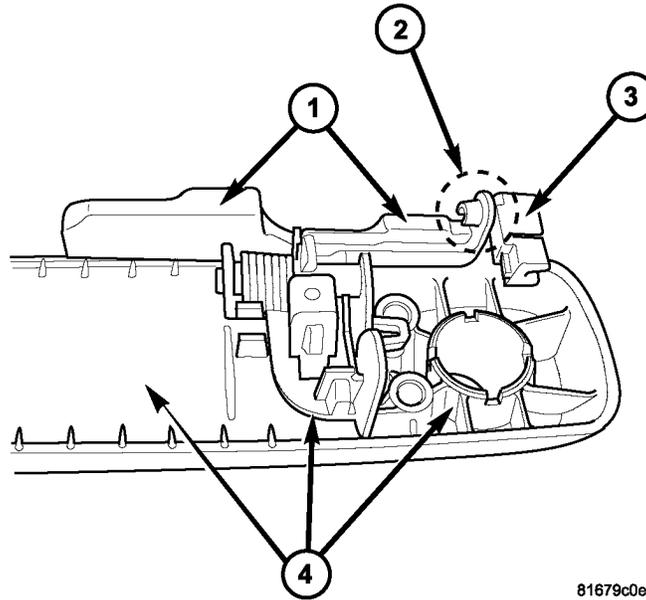
Fig. 2 DOOR HANDLE CLIP - TYPICAL

NOTE: Lubricate only the plastic clip-to-counterweight connection. Do not lubricate the latch rod-to-plastic clip connection.

- 1 - Counterweight
- 2 - Apply Lubriplate To This Connection ONLY- Lubricate Well
- 3 - Plastic Clip - Latch Rod
- 4 - Outside Door Handle - View From Backside

8. Apply Lubriplate grease to the latch rod plastic clip. The grease needs to be carefully applied where the plastic clip connects to the hole in the door handle counterweight(Fig. 2).
9. Rotate the plastic clip in the counterweight hole. This step is important to help distribute the Lubriplate.
10. Add a second application of Lubriplate grease to the clip and its connecting counterweight hole.
11. Rotate the plastic clip in the counterweight hole.
12. Install the latch rod to the plastic clip. Verify that the latch rod is fully engaged to the clip.
13. Verify repair.

6. Apply Lubriplate grease to the latch rod plastic clip. The grease needs to be carefully applied where the plastic clip connects to the hole in the door handle counterweight(Fig. 2).
7. Rotate the plastic clip in the counterweight hole. This step is important to help distribute the Lubriplate.
8. Add a second application of Lubriplate grease to the clip and its connecting counterweight hole.
9. Rotate the plastic clip in the counterweight hole.
10. Install the latch rod to the plastic clip. Verify that the latch rod is fully engaged to the clip.
11. Verify repair.
12. Install the glass run channel and attaching bolts. Tighten the attaching bolts to 10 Nm (90 in. lbs.).
13. Verify correct window glass operation.
14. Install the water shield.
15. Replace the door trim panel plastic retainers.
16. Install the door trim panel to the door.
