NUMBER: 23-031-06

Windshield Header Buzz Or Humming Sound

- 2005 - ****2006** (LX) 300/Charger****Magmun**
- **2006** (LE) 300C/300C Touring (International Markets)******
- **2005 - 2006** (WK) Grand Cherokee******
- **2005 - 2006** (WH) Grand Cherokee (International Markets)******

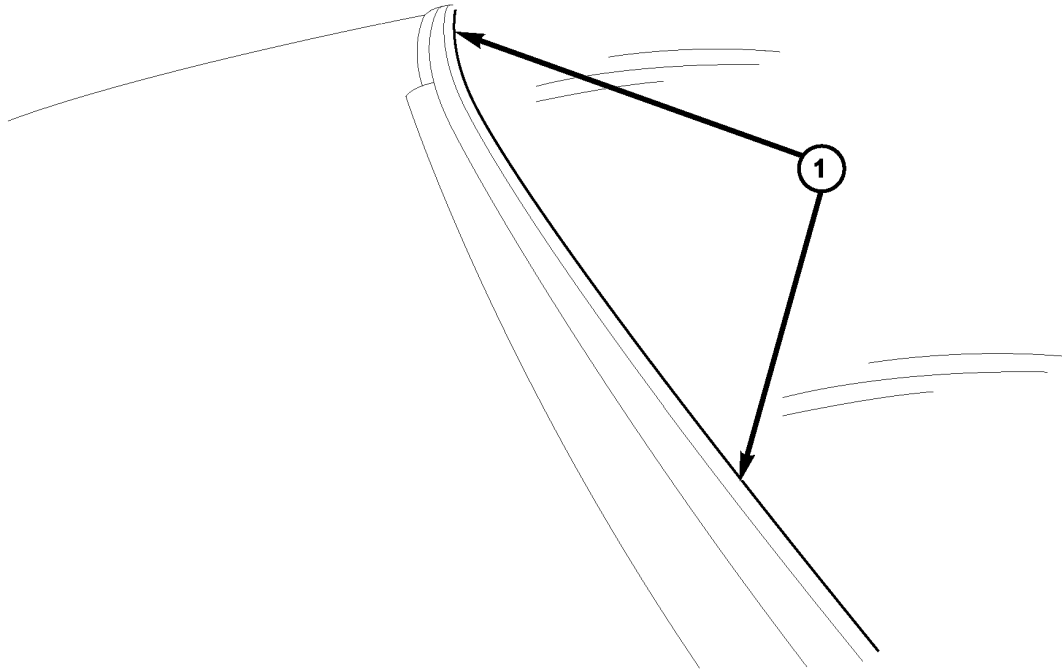
Fig. 1 JOINT TO BE SEALED

In warmer weather the vehicle operator may report a buzz or humming sound from the upper front windshield area particularly at speeds above 45 mph (72 kph). Some vehicles may have been built with the upper windshield molding partially rocked forward. When air passes over top of the tail section of the molding it may vibrate creating a buzz or humming sound and is more likely to occur in warmer ambient temperatures when the molding material is more flexible.

1. Use a trim stick to hold the tail section of the windshield molding away from the roof panel and use an alcohol wipe to clean all the way across the vehicle between the molding and roof panel.(Fig. 1).

1 - APPLY SEALER BETWEEN TAIL OF MOLDING AND ROOF PANEL

-
2. Use a trim stick to hold the tail section of the windshield molding away from the roof panel and apply MOPAR Silicone Windshield and Glass Sealer, p/n 04467708, in the joint between molding and the roof panel.
 3. If sealer squeeze out occurs, immediately wipe off the excess with a clean paper towel.
