NUMBER: 23-050-04

GROUP: Body

DATE: December 02, 2004

Water Leak In Area Of A-Pillar Grab Handle Or Overhead Console

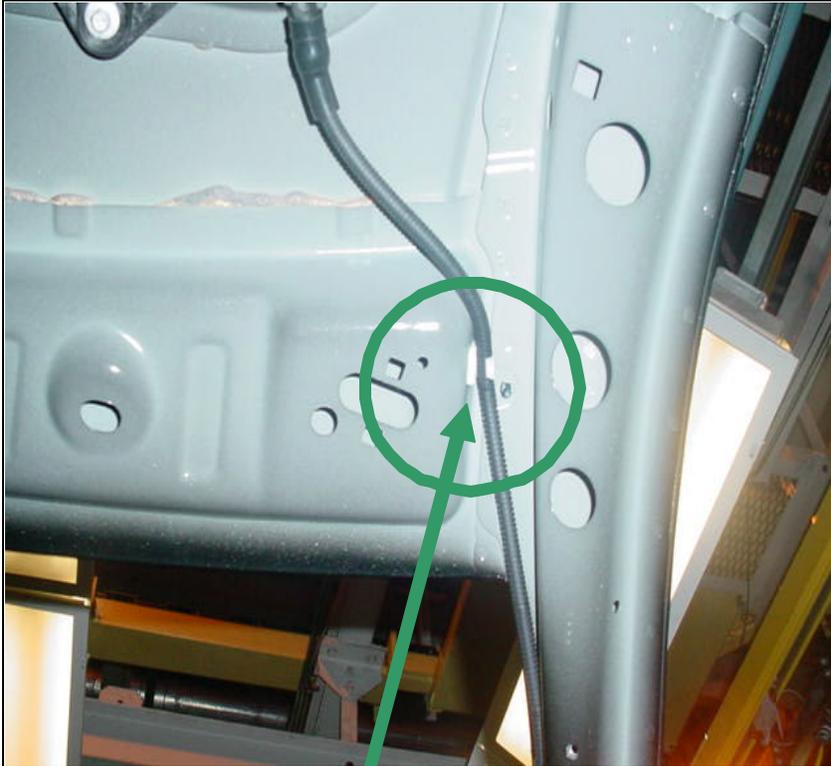
1. A pinched or collapsed front sunroof drain tube (left or right side) between the headliner and metal roof panel at the outboard sun visor attachment. The pinched front drain tube(s) may cause water to backup in the tube and overflow the sunroof water trough.

Good Job

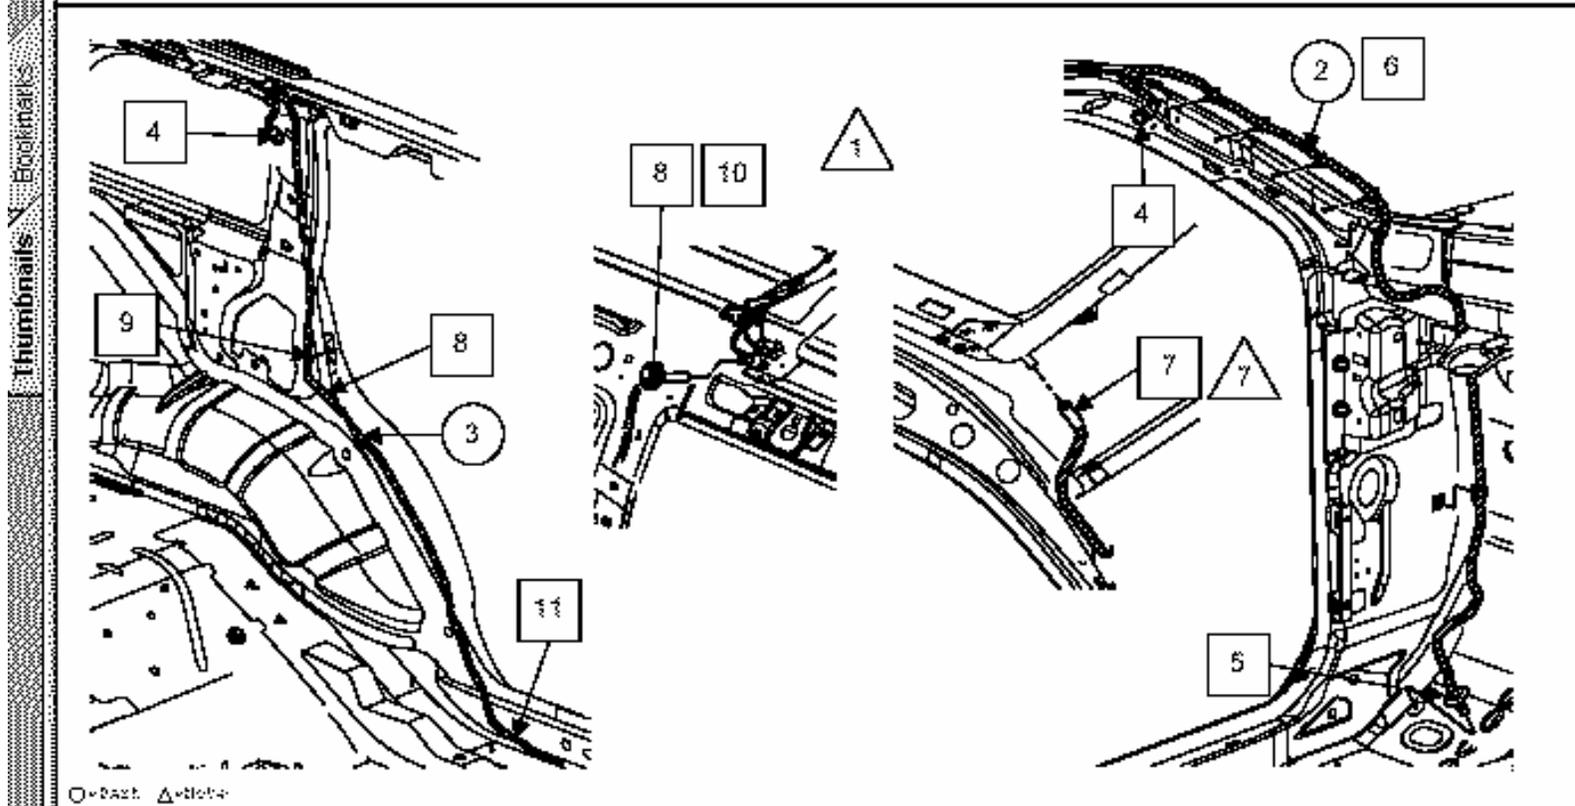
Rear and Front Drain Tube Routing

4. A restricted rear sunroof drain tube (left or right side) near the exit end of the drain

tube. The rear sunroof drain tube is routed down along the C-pillar. The end of the tube(s) may turn back on itself during installation at the bottom of the C-pillar. Sound deadening foam is applied to the C-pillar cavity once the drain tube is installed. The sound deadener may close off the end of the drain tube. (Number 11 in Picture)
