SUBJECT: Rapid Response Transmittal Service Action #04-031
Release Clip Not Removed From Power Steering Return Hose Clamps

INVOLVED VEHICLES: 2005 (WK) Grand Cherokee

NOTE: This bulletin applies to vehicles equipped with a 5.7L engine (sales code EZB) built prior to December 11, 2004 (MDH 1211XX).

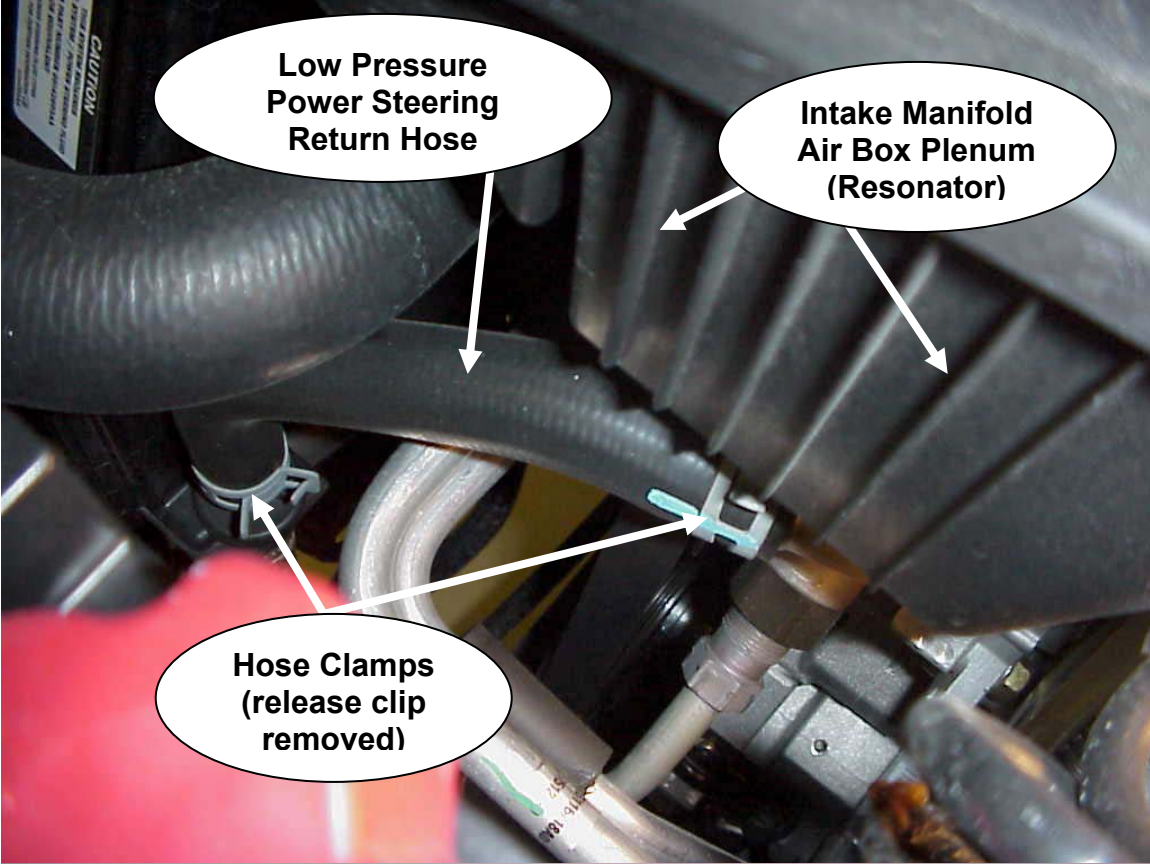
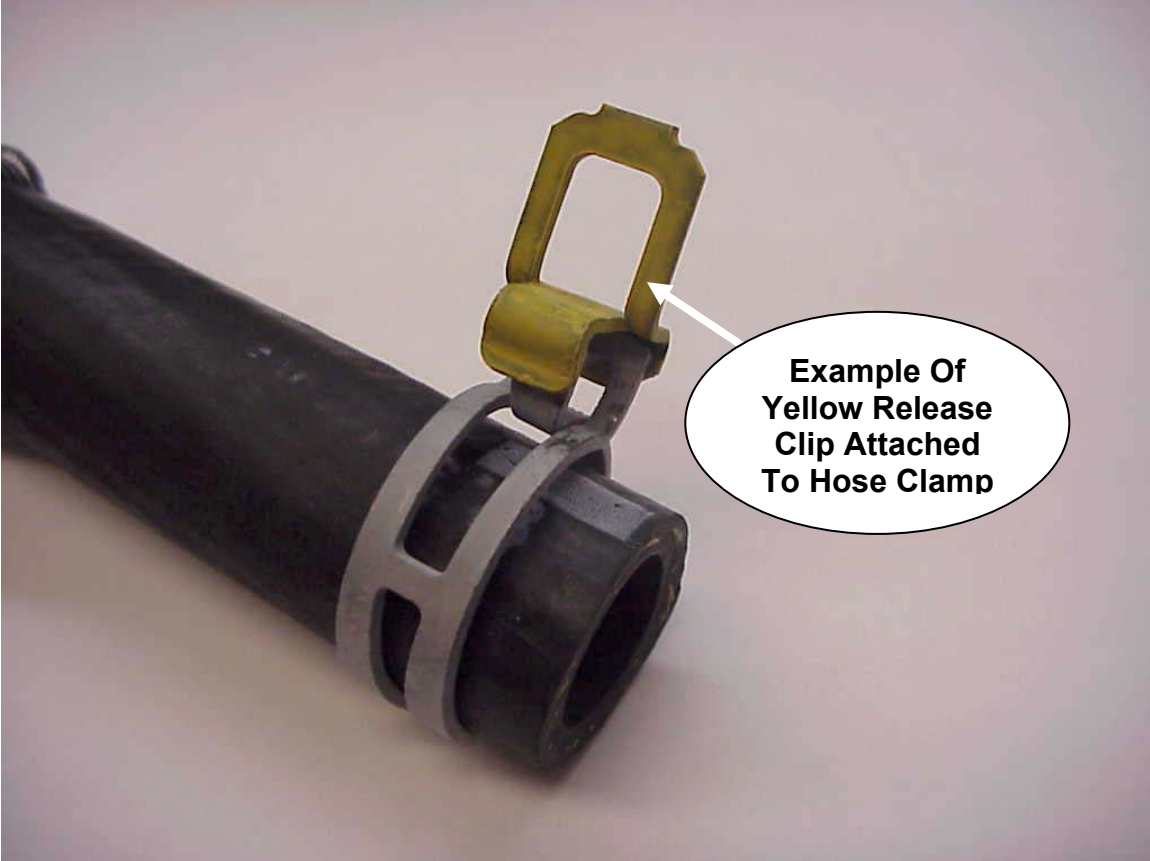
A small number of vehicles may have release clips that have not been removed from one or both hose clamps used to secure the low pressure power steering return hose. The suspect hose clamps are used to connect the low pressure power steering return hose to the power steering reservoir and pump.

2. Verify if the power steering return hose and the two (2) attaching clamps are installed correctly and that the yellow release clip has been removed.

4. If the hose clamps on the power steering return hose have not had the yellow release clip removed from one or both clamps then proceed to the next step.

5. Remove the intake manifold air box plenum (resonator) from the vehicle to gain access to both power steering return hose clamps.
6. Prior to removing a release clip, verify that power steering return hose and both clamps are correctly installed to the reservoir and pump.

7. Remove the yellow release clip present on one or both return hose clamps.
8. Install the intake manifold air box plenum (resonator). Tighten the plenum hose clamps to 3.4 Nm (30 in. lbs.). Tighten plenum attaching bolts to 4.5 Nm (40 in. lbs.).
