TO: ALL JEEP DEALERS

SUBJECT: RAPID RESPONSE TRANSMITTAL #08-043
Rear Window Belt Molding Noise, Loose or Sticking

2008 (WK) Grand Cherokee

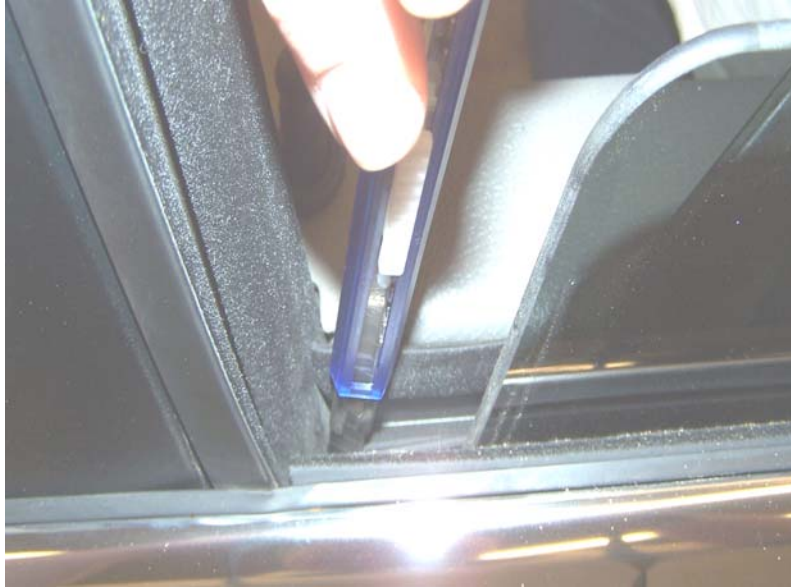
FIGURE 1

Some vehicles were built with a rear door window belt molding that can exhibit a moan sound or may stick and bind or become loose.

1. Roll both the rear windows down fully.
2. Insert sharp, slim razor knife into slot near lock knob and cut the inner lower secondary seal lip. (Fig 1) & (Fig 2).
