March 19, 2010

SUBJECT: RAPID RESPONSE TRANSMITTAL / SERVICE ACTION #10-018
Tailpipe Rattle

2010 (WK) Grand Cherokee

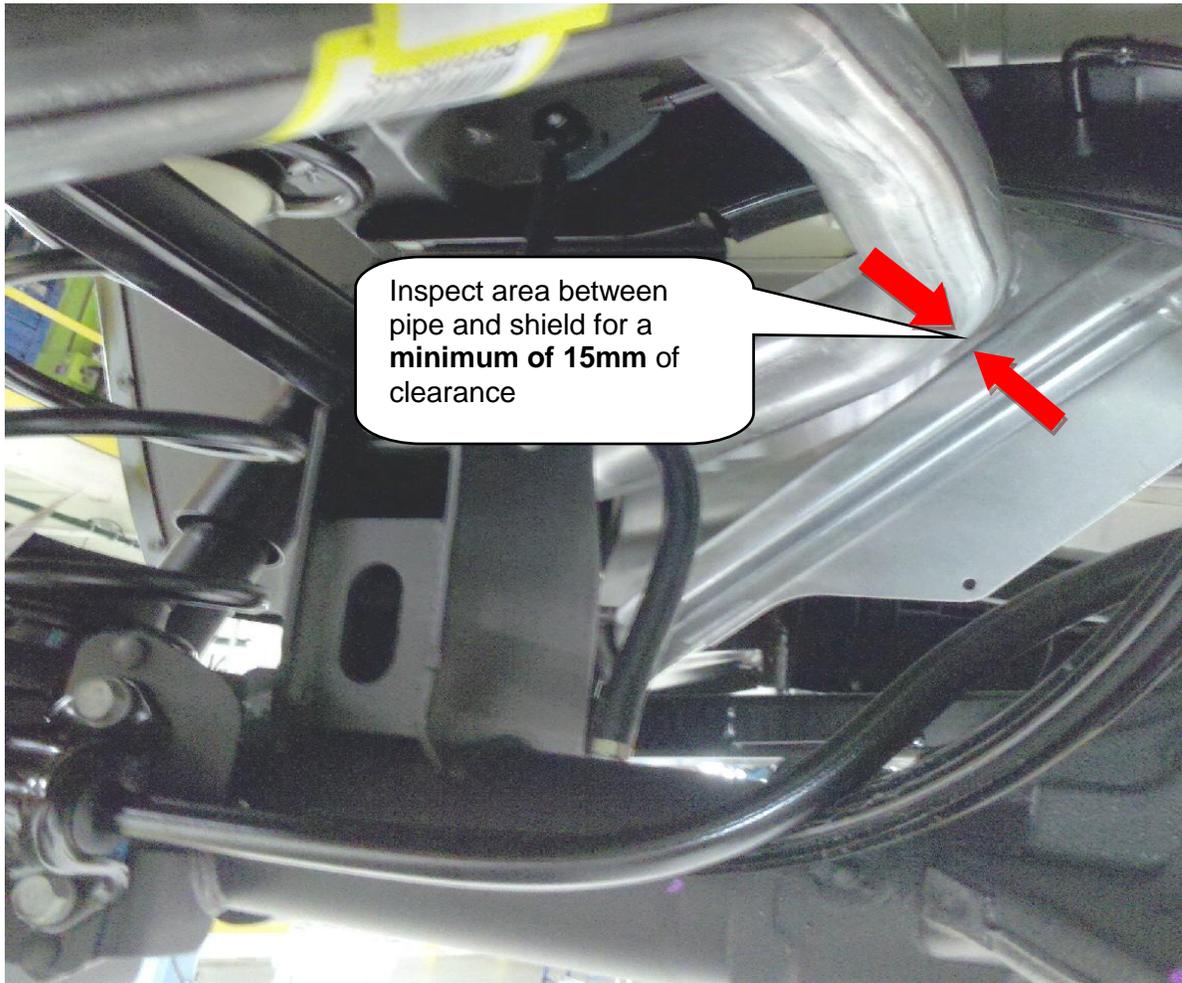
Figure 1- Measurement Location

A number of vehicles may have been shipped with a tailpipe that can contact the rear heat shield creating a rattle type noise under certain conditions.

1. Raise the vehicle and inspect the clearance of the tail pipe to the rear heat shield (Fig 1). Minimum clearance should be 15 mm (0.59 In). Figure 1 is an example of the proper clearance between the heat shield and the tail pipe.

2. Is the clearance at least 15 mm (0.59 In)?
 - a. **YES**>> Inspection complete, no further action required
 - b. **NO**>> Proceed to step 3.
3. Loosen the upper heat shield nut and remove the lower heat shield nut (Fig 2).
