Dealer Service Instructions for:

Safety Recall E13

Transmission Fill Tube Oil Seal

2005 (WK) Jeep® Grand Cherokee

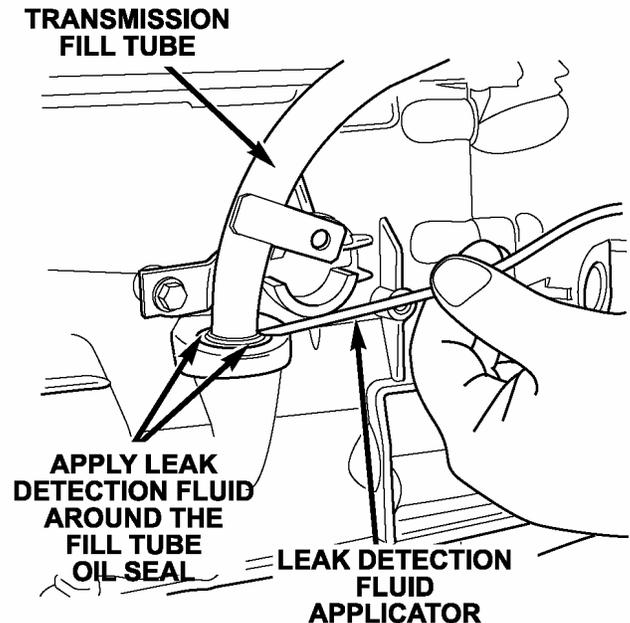
Figure 2

- If **bubbles** appear around the fill tube oil seal, the seal is leaking. Remove the air pressure regulator and continue with **Section B – Road Testing the Vehicle for Torque Converter Shudder/Buzz**.

- If there are **no bubbles** coming from around the fill tube oil seal, the seal has not been leaking. Remove the air pressure regulator and continue with **Section E – Fill Tube Oil Seal Replacement**.

6. With the transmission pressurized to 2 psi (14 kPa), raise the vehicle on a hoist.
7. Apply the leak detection fluid around the transmission fill tube oil seal area (Figure 2).
