NUMBER: 23-034-05

Liftgate Secondary Seal - Remove Seal If Loose, Misaligned, Or Wrinkled

2005 (WK) Grand Cherokee

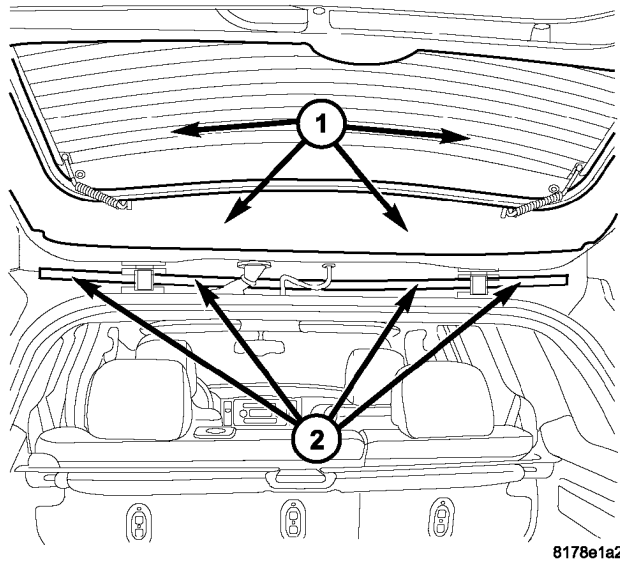
Fig. 1 LIFTGATE SECONDARY SEAL

The customer may notice that the liftgate secondary seal is loose, mis-aligned, or distorted. The secondary seal is located along the inner top edge of the liftgate.

- 1 - Liftgate
- 2 - Secondary Seal - Remove (Do Not Replace)

1. Raise liftgate.
2. Remove the three piece liftgate secondary seal from the liftgate (Fig. 1).

3. Remove the residual seal adhesive. Apply a small amount of an appropriate remover (such as: Throttle Body Cleaner or Brake Parts Cleaner) to the adhesive. Apply adhesive remover carefully. Protect surrounding plastic and other exposed surfaces from the adhesive remover.
4. Close liftgate.
