RADIO REMOVAL: 2005-2010 LX

CHRYSLER 300

DODGE CHARGER / MAGNUM

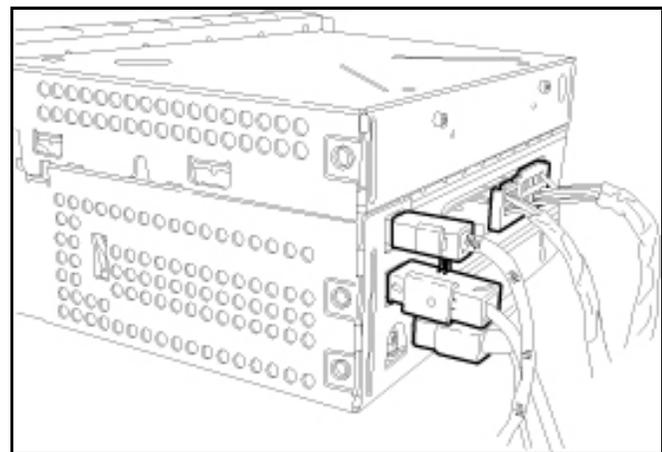
1. Disconnect and isolate the battery negative cable.
2. Remove the instrument panel center bezel (see pages 2-3)
3. Remove the mounting fasteners.

CAUTION: Pulling the antenna cable straight out of the radio without pulling on the locking antenna connector could damage the cable or radio.

4. Disconnect the antenna cables.
5. Disconnect the electrical connectors and the remove radio.

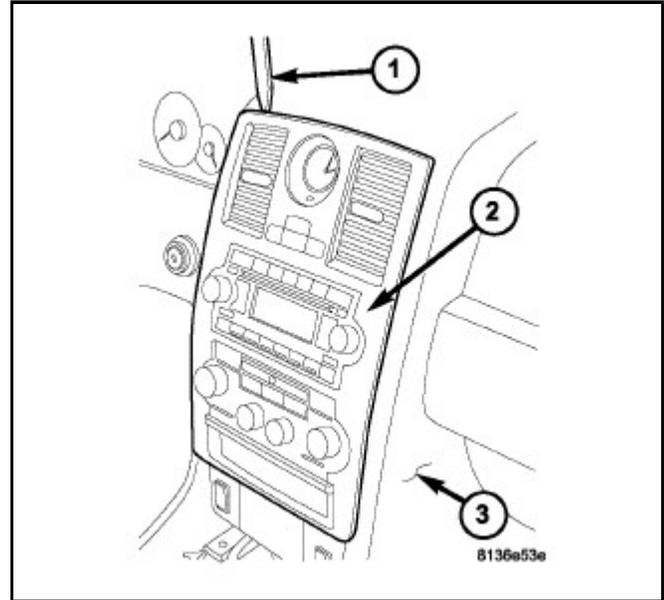
1. Before proceeding with the following repair procedure, review all warnings and cautions.
2. Using a trim stick C-4755 or equivalent (1), remove the center bezel (2) from the instrument panel (3) by releasing the snap retainers from the instrument panel.

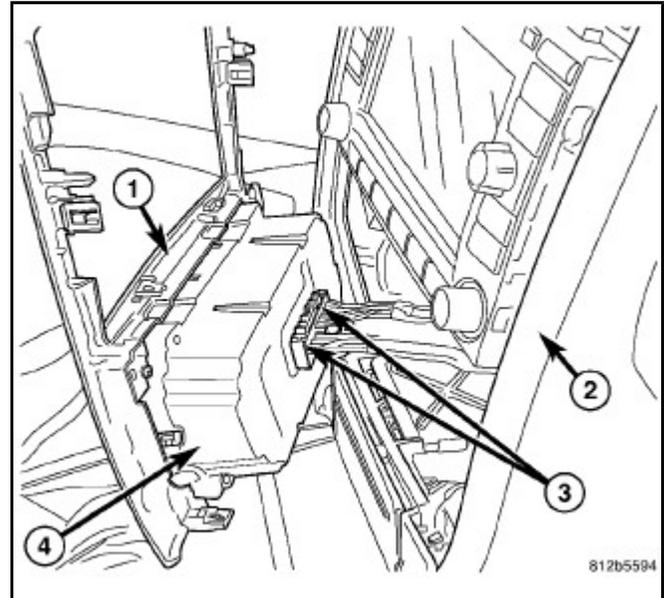
3. Disconnect the electrical connectors (3) from the A/C - heater control (4) and the clock and remove the center bezel (1) from the vehicle.

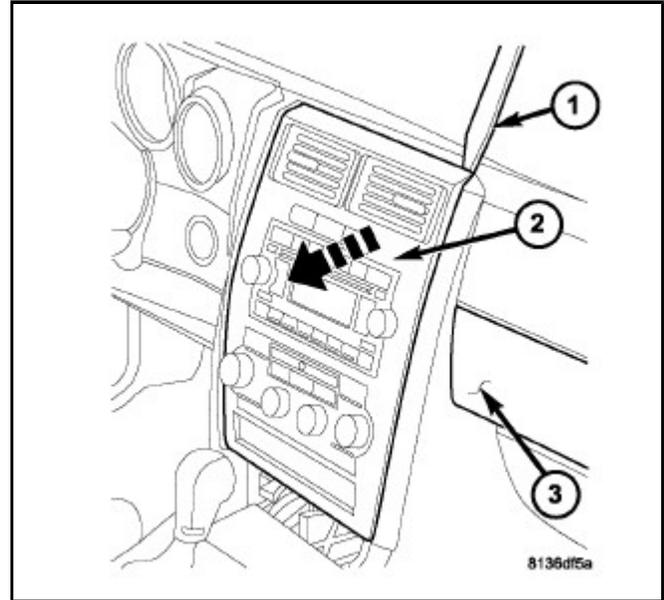
1. Before proceeding with the following repair procedure, review all warnings and cautions.
2. Using a trim stick C-4755 or equivalent (1), remove the center bezel (2) from the instrument panel (3) by releasing the snap retainers from the instrument panel.

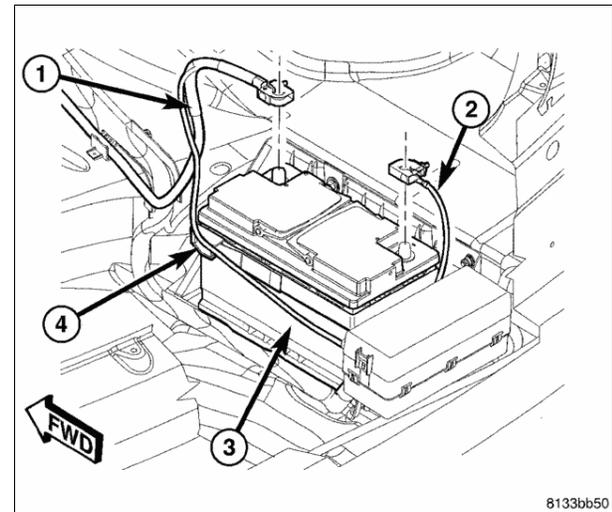
1. Connect the battery negative cable (2) to the battery post and tighten the clamp nut.
2. Install the rear compartment floor trim panel.
