# F58-C REMOVAL

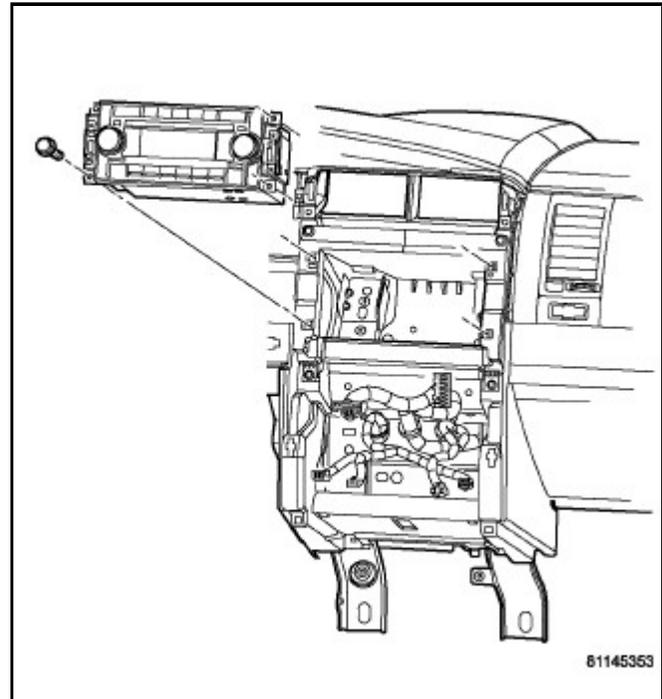
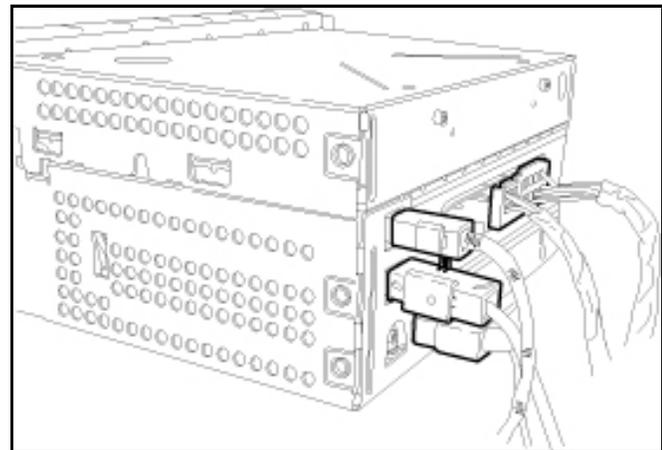
1. Disconnect and isolate the battery negative cable.
2. Remove the instrument panel center bezel (see page 2)
3. Remove the mounting fasteners.

**CAUTION:** Pulling the antenna cable straight out of the radio without pulling on the locking antenna connector could damage the cable or radio.

4. Disconnect the antenna cables by pulling the locking antenna connector away from the radio.
5. Disconnect the electrical connectors and remove the radio.

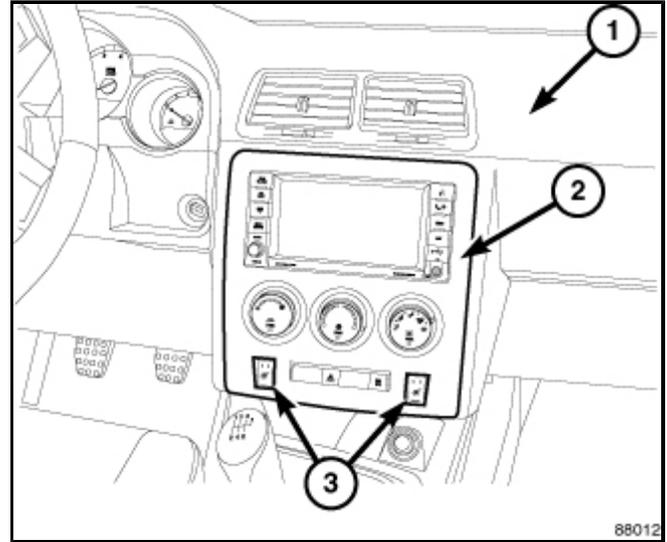
1. Before proceeding with the following repair procedure, review all warnings and cautions.
2. Using trim stick C-4755 or equivalent, remove the center bezel (2) from the instrument panel (1) by releasing the snapretainers from the instrument panel.
3. Disconnect the electrical connectors.
4. Remove the center bezel from the vehicle.

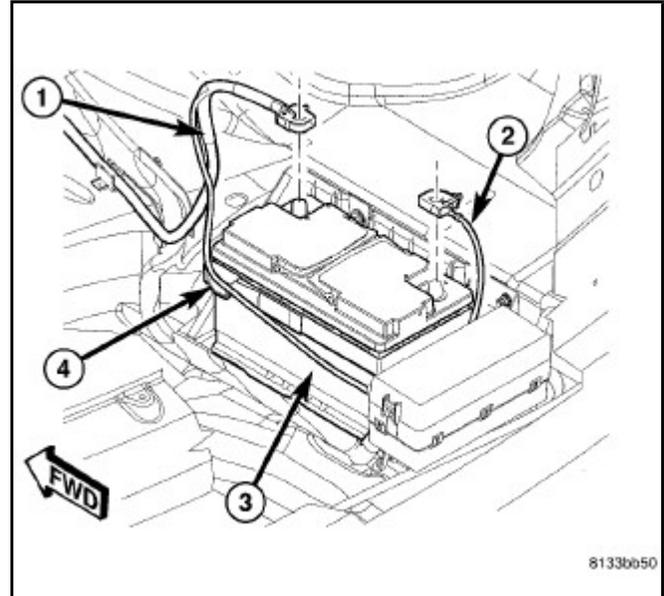
1. Connect the battery negative cable (2) to the battery post and tighten the clamp nut.
2. Install the rear compartment floor trim panel.
